# BOURLAND TRESTLE HISTORIC PRESERVATION OPTIONS

HISTORIC PRESERVATION OPTIONS  
FOR THE

BOURLAND TRESTLE  
IN THE  
STANISLAUS NATIONAL  
FOREST

January 5, 2000

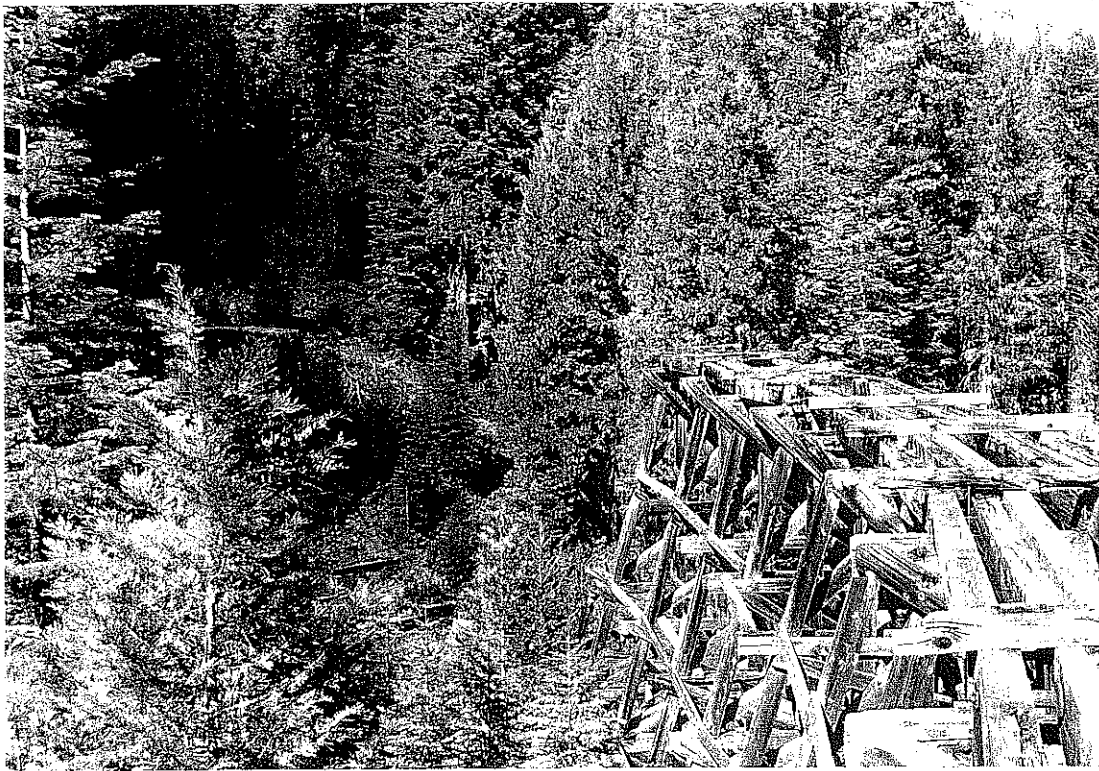
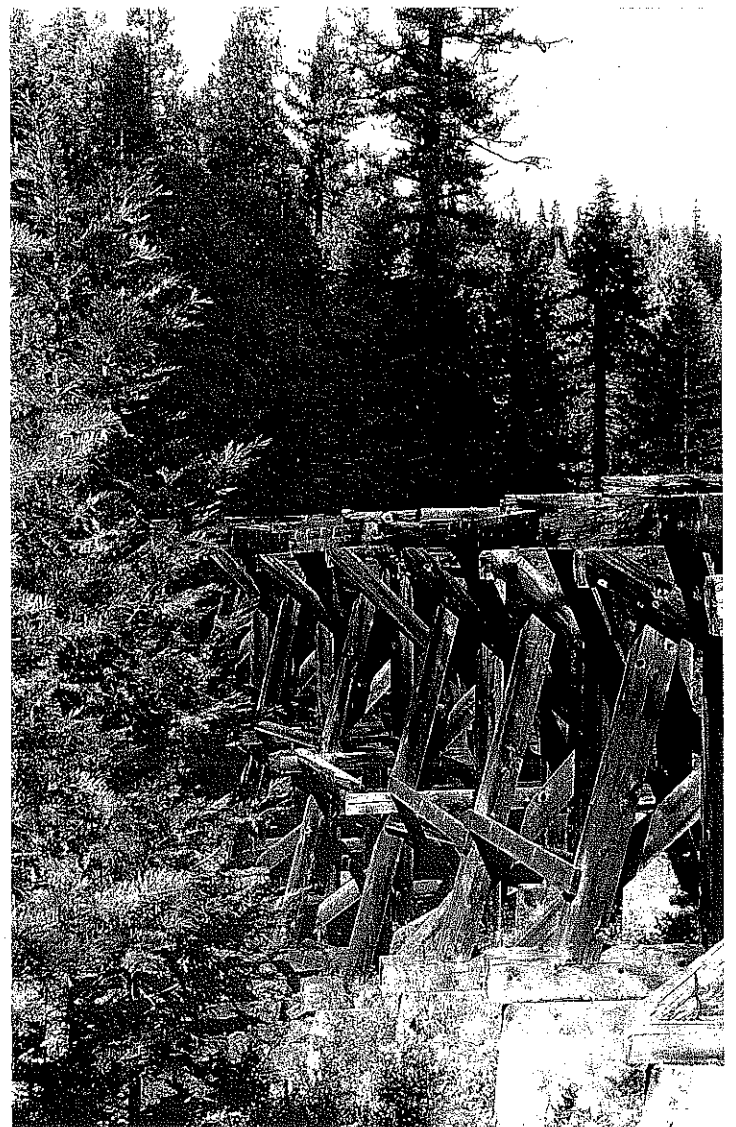
#### LANDING AT #23

The cap is dry rotted and crushing and must be replaced. The #4 and #6 Stringers are gone and must be reinstalled. Stringers #1, #2, #3 and #5 are all fixable. The concrete landing wall has a vertical crack at the connection on the downstream side of the two perpendicular concrete walls. It should be reevaluated. (Stringers from Bent #22 to the landing at #23).
